Volkswagen AG has established that on Golf vehicles of a limited production period there is a possibility that the seat belt on the front passenger side is not correctly attached to the lower anchoring point. Volkswagen has written to all impacted customers.

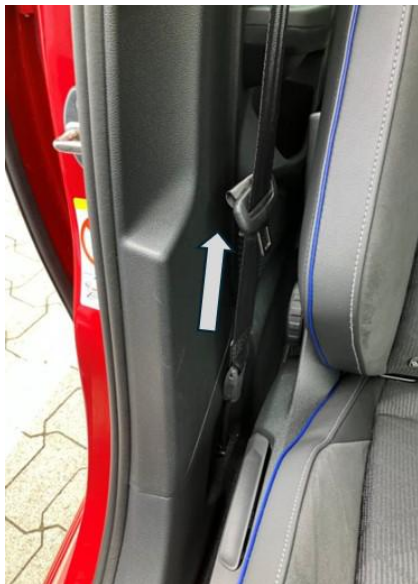
Please firmly pull on the belt webbing of the lower anchoring point in the direction of the arrow (see illustration) on the front passenger seat.

If the belt webbing does not detach from the anchoring point then the vehicle poses no risk.

If the belt webbing detaches from the lower anchoring, please do not use the front passenger seat until your vehicle is repaired.

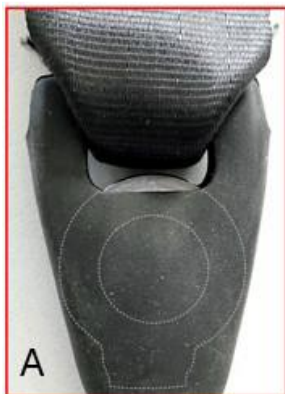
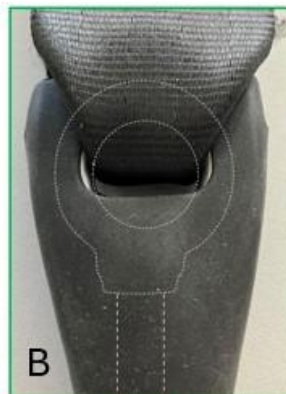
Check whether the belt webbing has been threaded through both the rubber grommet and the metal lug. Illustration

B. In this case, the vehicle poses no risk.

If the belt webbing is only threaded through the rubber grommet, please do not use the front passenger seat until the vehicle is repaired.

If you have received a letter saying that your vehicle is affected, please make sure to contact your local **Volkswagen Authorised Repairer** as soon as possible to make an appointment. The **Volkswagen Authorised Repairer** closest to you can be found on <https://www.volkswagen.co.uk/find-a-retailer>, should you have any further concerns please contact Volkswagen Customer Services on **0800 9540225**.
